# Manhole Inspection Summary

Manhole # S21A\_\_044MH

Insp Date: **9/18/07 6:32 AM**

**Location** Address: **1614 EDMONDSON AVE**

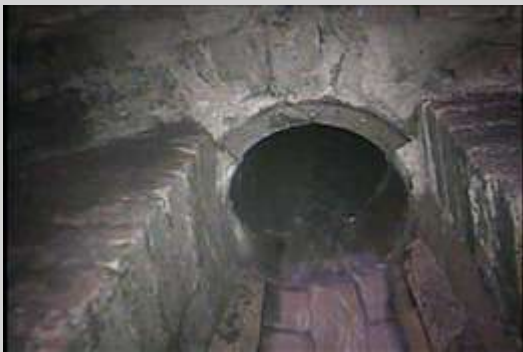
12 O'Clock Outflow

8 in. Circular Gravity Sewer  
Pipe Out @ 12 O'Clock

Pipe Height: **8.4** (in.) Rod and Bar (Angled)  
Pipe Material: **Clay** ☐ Pipe Lined  
Invert Depth: **9.72** (ft.) Flow Characteristics: **Slow**  
Deposits: ☒ None ☐ Mud ☐ Sludge ☐ Debris ☐ Grease  
Silt Depth: (in.) Deposits Extent:  
Infiltration: **None** Pipe Seal Cond: **Sound**
